Final Report: Targeted Inspection of CN Operations (Phase 1 of Transport Canada Action Plan to Address CN Safety Issues)

January 5, 2006

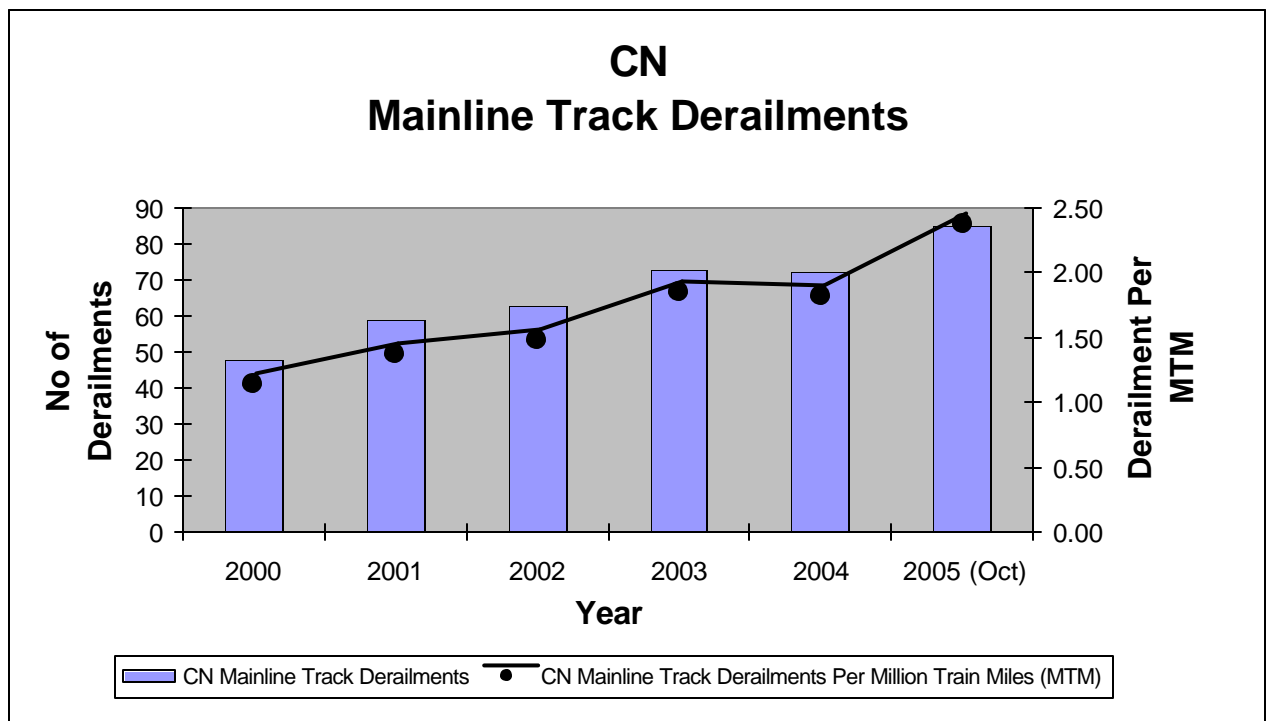
Exhibit 1. Mainline Track Derailments

Note – includes Mainline Track Derailment data on BC Rail effective July 14, 2004

The number of CN Mainline Track Derailments (where CN was both track owner and train operator) has jumped from 48 in 2000 to 72 in 2004, an increase of 50%. CN's 85 derailments to October 2005, represents an increase of over 75% in the number of CN Mainline Track Derailments since 2000.

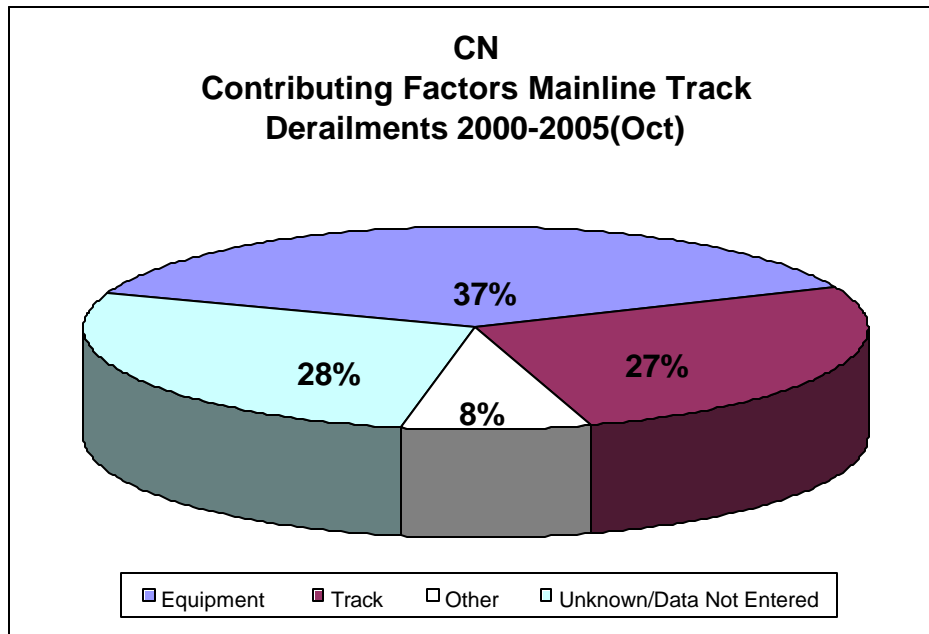
Exhibit 2 CN Mainline Track Derailments - Contributing Factors

As illustrated below, two of the major contributing factors² to CN mainline track derailments over the last five years have been Track and Equipment. Since 2000, Equipment has been identified as a contributing factor in 37% of CN's Mainline Track Derailments (where CN was both track owner and train operator), followed by Track as a contributing factor in 27% of the derailments. Note that some derailments have been identified with multiple contributing factors.

Contributing Factor	Number of Derailments					
	2000	2001	2002	2003	2004	2005*
Equipment	21	25	27	32	27	27
Track	16	13	16	26	26	16
Other**	4	7	7	4	6	5
Unknown/Data Not Entered***	9	16	18	12	20	41

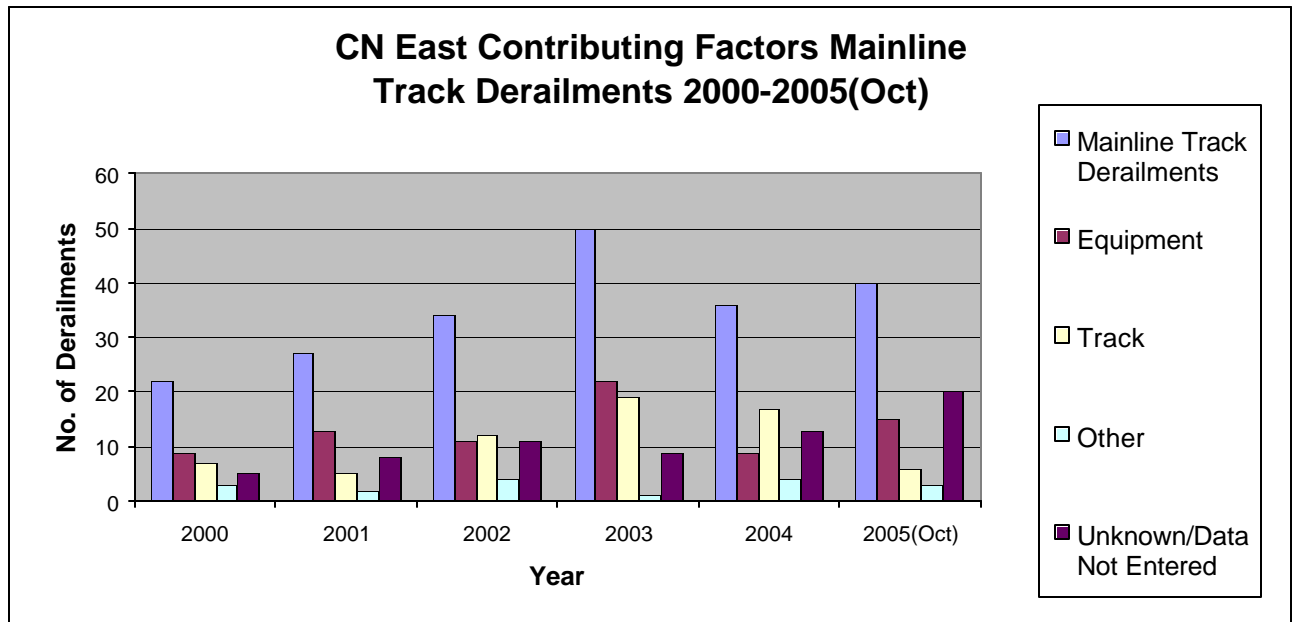
Exhibit 3 CN East – Contributing Factors to Mainline Track Derailments

Exhibits 3 and 4 show a breakdown of the contributing factors to CN Mainline Track Derailments by CN Region³. Derailments due to track are higher in CN's East Region compared to CN's West Region. Equipment is the predominant contributing factor in both Regions.
